Manhole Inspection Summary

Manhole # S21YY1013MH

Location Address: **5 ROLAND MEWS RD**

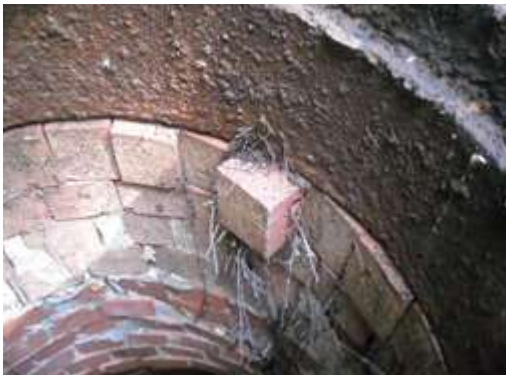
Defect

Infiltration: ☐ None ☐ Joint ☐ Cracks ☒ **Mortar** ☐ Roots ☒ **Wall**

Surcharge ☒ **Evidence Of Surcharge** Depth: **1** (ft.) ☐ Active Surcharge Present

Barrel infiltration. Evidence of surcharge - Bench debris.

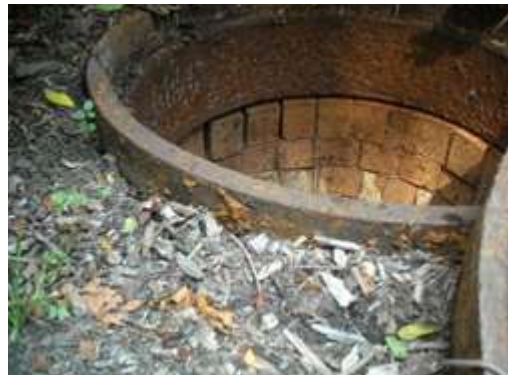
Defect

Frame Offset: **0** (in.) Condition: ☐ Sound ☐ Cracked ☒ **Leaks**

Condition: ☐ Sound ☐ Cracked ☒ **Root Intrusion** ☒ **Loose Brick** ☐ Deteriorated

Infiltration: ☐ None ☒ **Joint** ☐ Cracks ☒ **Mortar** ☒ **Roots** ☐ Wall

Frame leaks. Adjustment loose brick, root intrusion and infiltration.

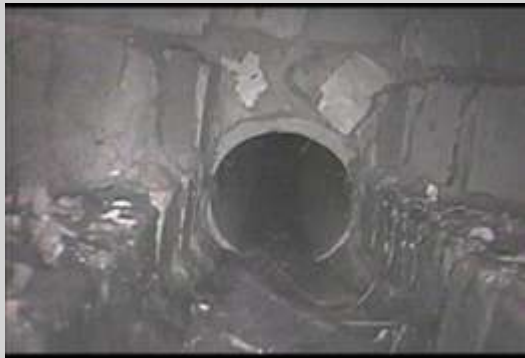
8 in. Circular Gravity Sewer Pipe Out @ 12 O'Clock

Infiltration: **Evidence** Pipe Seal Cond: **Unknown**
